Union Mills :

**A Study for the Improvement,
Restoration, and Protection of
Mill Pond...**

**Save Our Pond Committee
Union Mills, IN 46382**

February 1990

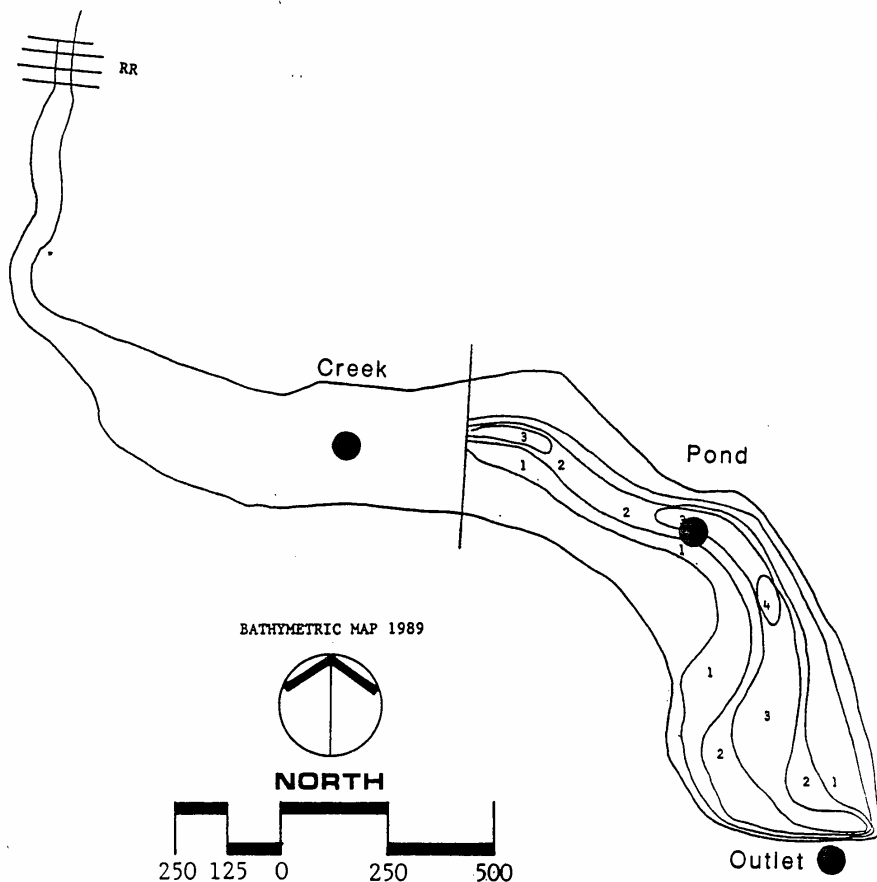
Figure 1. Water Quality Sampling Stations in Mill Pond for 1989.

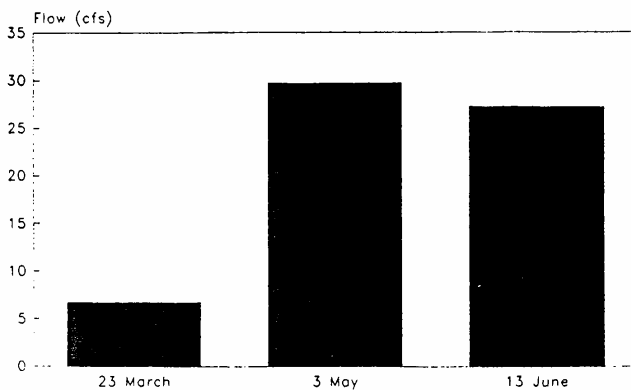
Figure 2. Flow at Individual Sampling Stations for Three Dates in 1989.

Results of our water quality investigations are presented in Table 1. Flow in the creek decreased throughout spring and into summer, while that of the outlet was lowest during March (Figure 2). With the exception of March, flow from the outlet was slightly greater than measured in the creek. While the creek pH remained constant throughout the study, that of both the pond and outlet increased progressively reflecting the seasonal expansion in weed populations during spring into summer with accompanying elevation in photosynthetic activity (Figure 3).

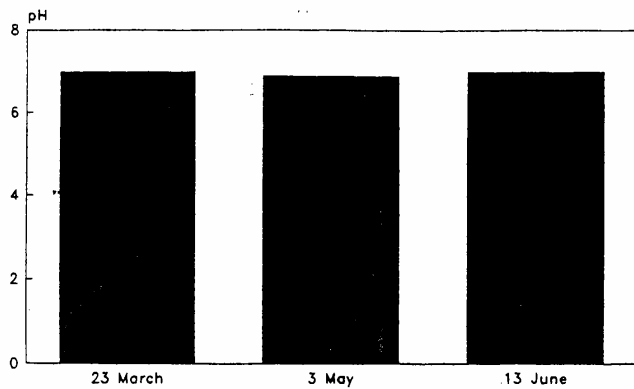
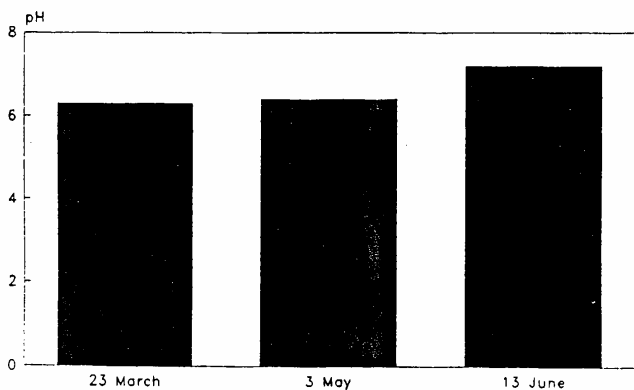
Figure 3. pH at Individual Sampling Stations for Three Dates in 1989.

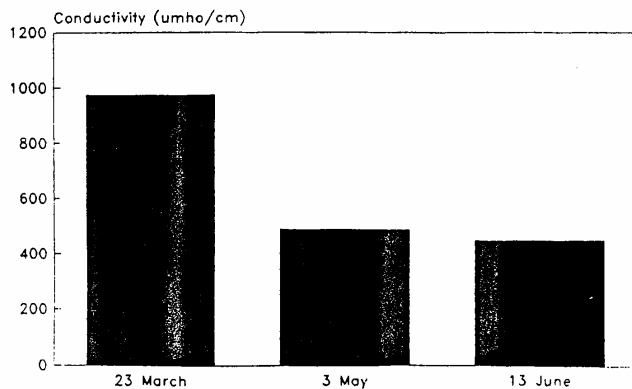
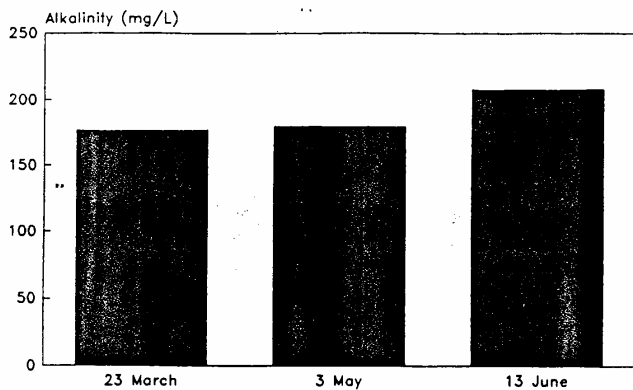
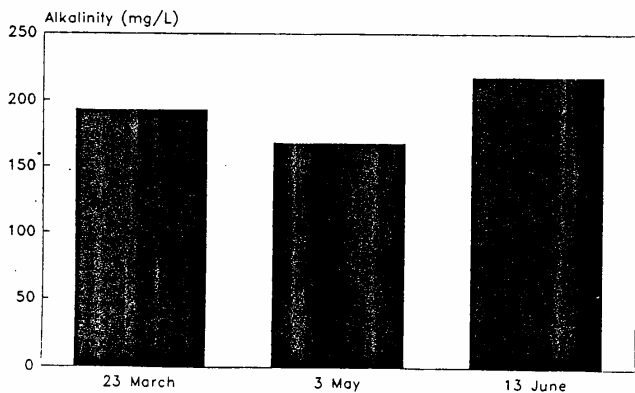
Figure 4. Conductivity at Individual Sampling Stations for Three Dates in 1989.

Two parameters, conductivity and alkalinity, were included in the present investigation in order to delineate the extent of cation and anion release from the watershed. Such parameters are useful for identifying the seasonality of watershed runoff and erosion. Conductivity (Figure 4) decreased throughout the study period concurrent with declining flow in the creek. An opposite pattern was displayed by alkalinity (Figure 5), a measure of the calcium

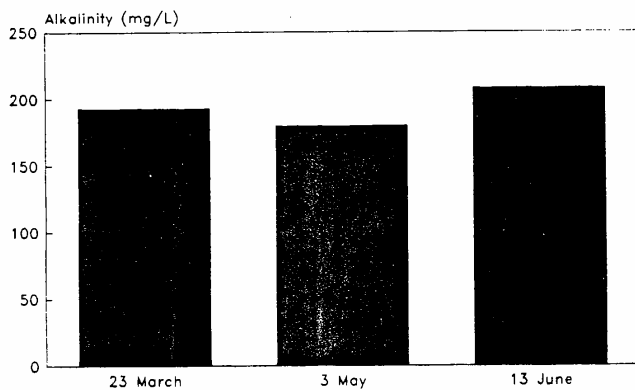
Figure 5. Alkalinity at Individual Sampling Stations for Three Dates in 1989.

carbonate content of water. Such values of conductivity and alkalinity are characteristic of other eutrophic lakes in northern Indiana.

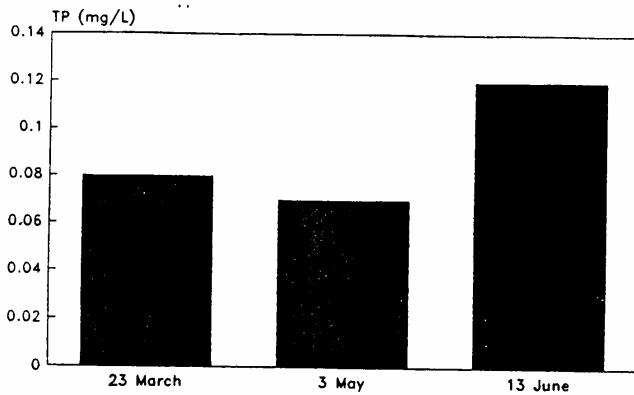
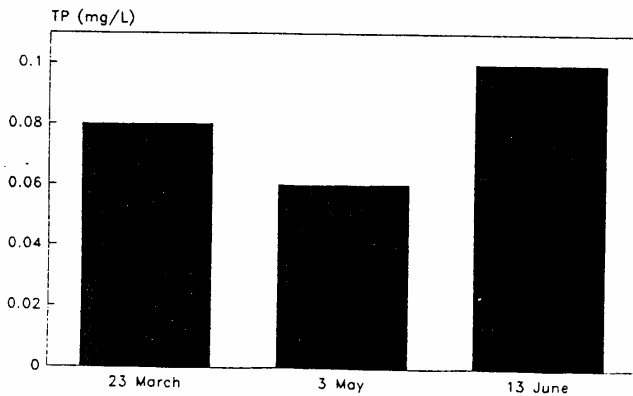
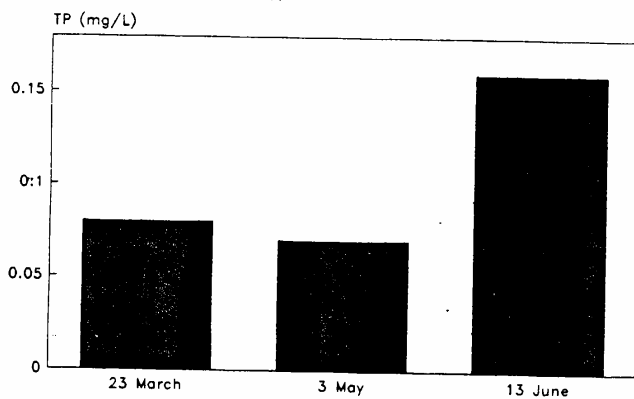
Figure 6. Total Phosphorus at Individual Sampling Stations for Three Dates in 1989.

Phosphorus and nitrogen are the two nutrients most likely to be limiting weed and algal growth in lakes. It is generally accepted that increasing either of these parameters will stimulate plant photosynthesis and biomass thus promoting eutrophication. Total phosphorus values at all three stations declined between March and May then rose to maximum levels during June (Figure 6). Such a trend is commonly observed in Indiana and reflects runoff from fields during spring snow melt and rains during March, stabilization of watershed release during May via growing vegetation, and finally pulsed release of phosphorus reflecting fertilization of crops during late spring.

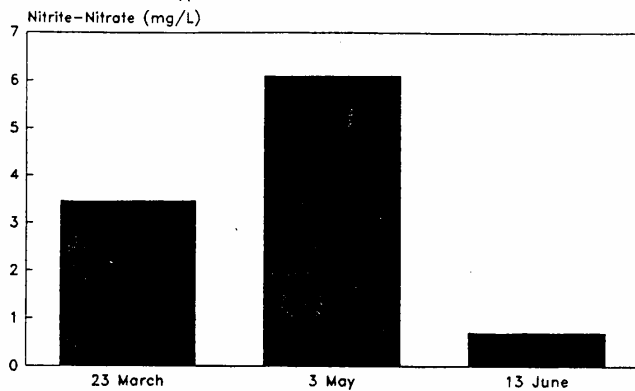
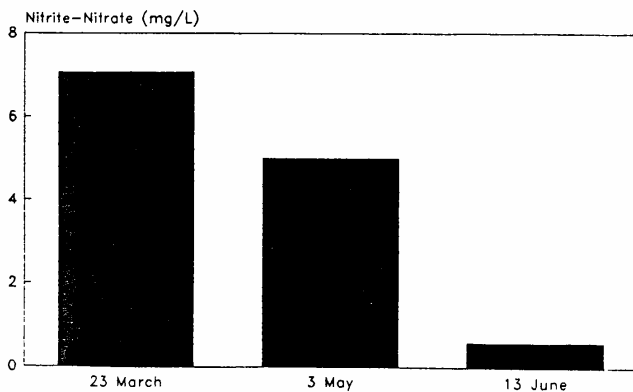
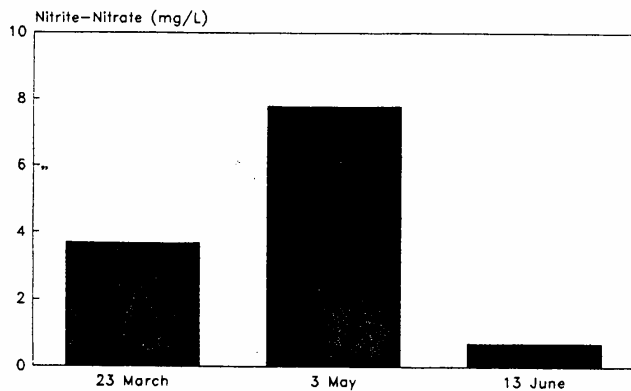
Figure 7. Nitrate-Nitrite Nitrogen at Individual Sampling Stations for Three Dates in 1989.

Nitrogen has been reported as nitrite-nitrate (Figure 7). Unlike total phosphorus, nitrogen values were minimal during June. In general, values were characteristic of eutrophic lakes in northern Indiana. The final water quality parameter measured was total suspended solids (Figure 8). Values failed to display a pronounced seasonal pattern but in general were not considered elevated from values observed for other watersheds in northern Indiana.

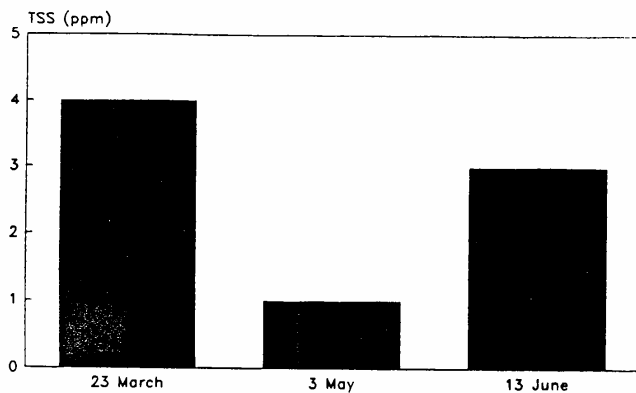
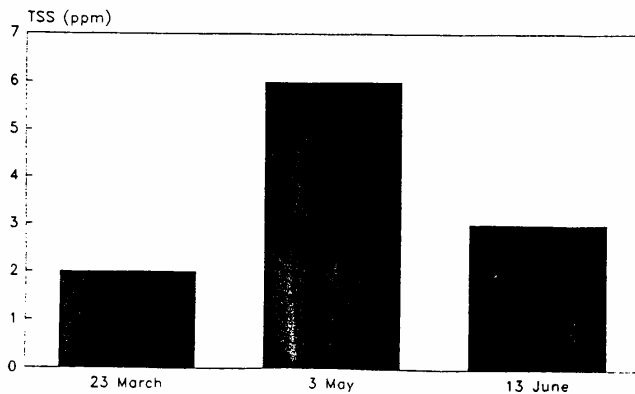
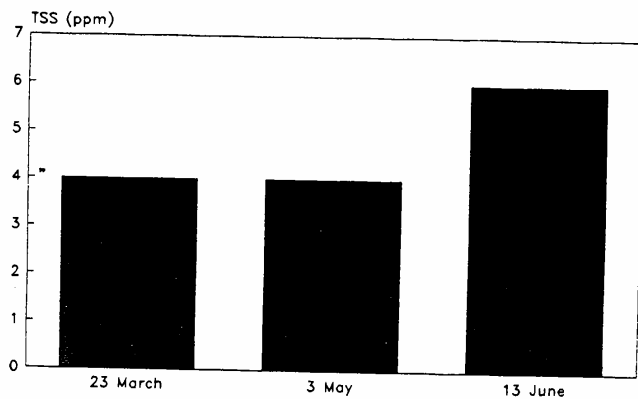
Figure 8. Total Suspended Solids at Individual Sampling Stations for Three Dates in 1989.

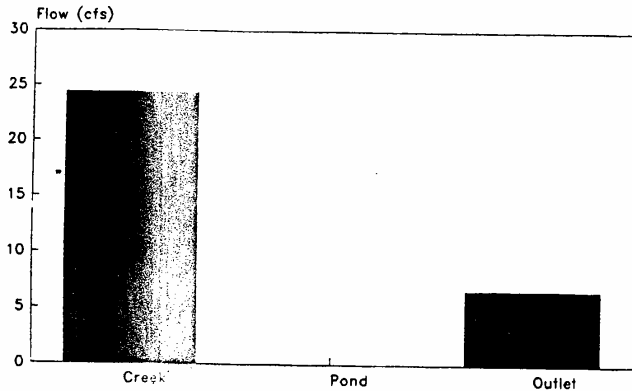
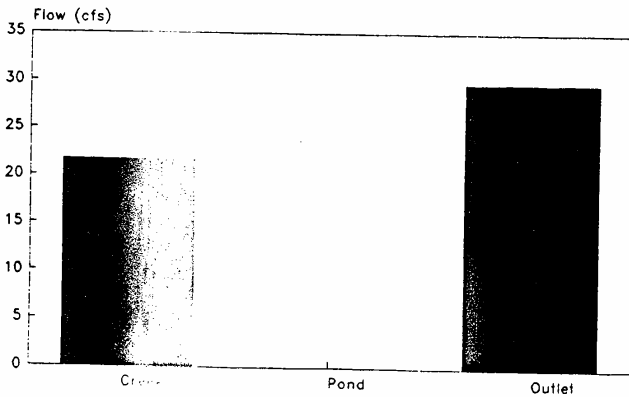
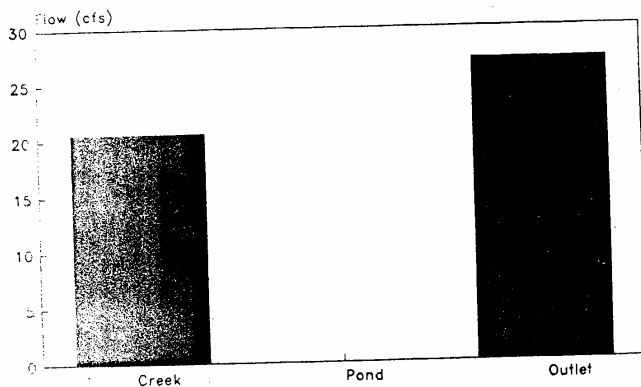
Figure 9. Comparison of Flow Among the Three Stations for Individual Sampling Dates of 1989.

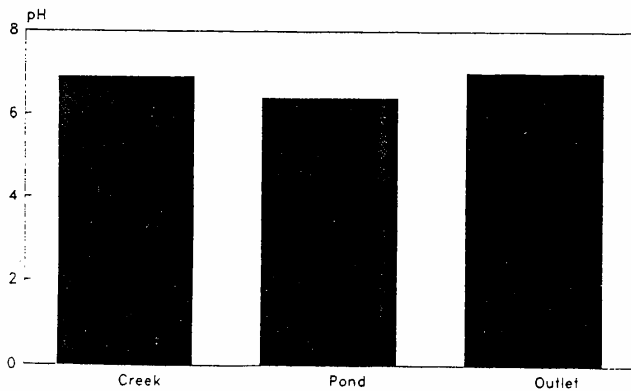
Figure 10. Comparison of pH Among the Three Stations for Individual Sampling Dates of 1989.

Pond pH values during both March and May were slightly lower than observed at the creek station, but water exiting the pond displayed a slight elevation in values over the initial pond station (Figure 10). Values for both pond and outlet during June were slightly greater than in the incoming stream suggesting that the great photosynthetic activity of the aquatic weeds in the pond elevates pH somewhat over background levels. Plant biomass during both March and May was not extensive enough to have a marked effect on pH.

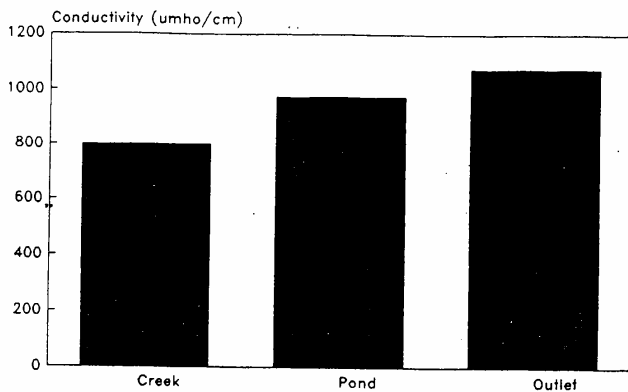
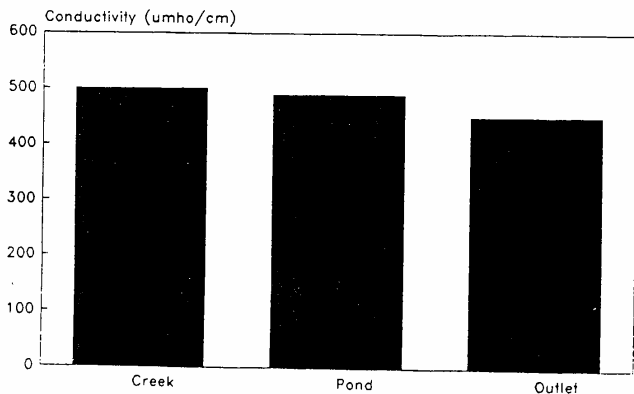
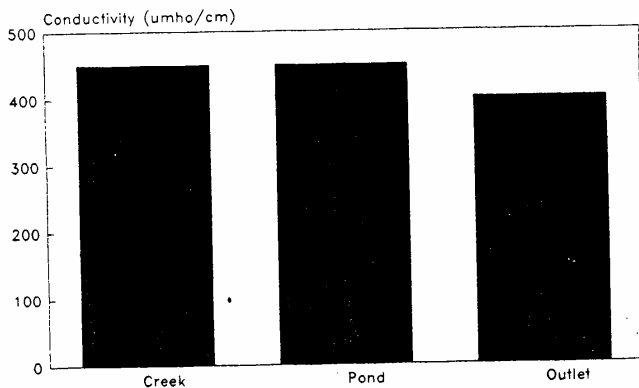
Figure 11. Comparison of Conductivity Among the Three Stations for Individual Sampling Dates of 1989.

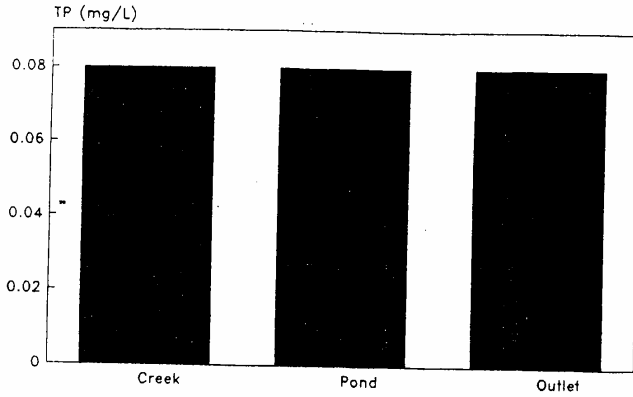
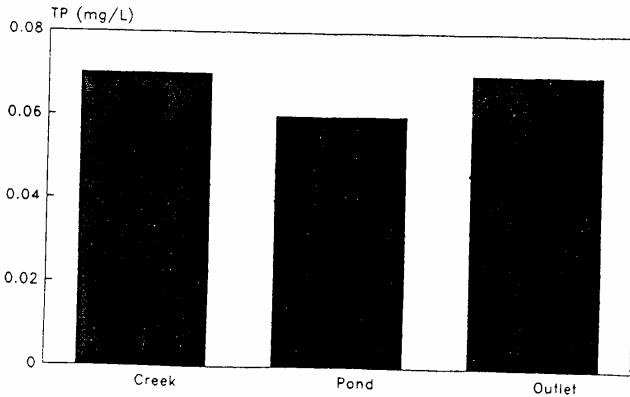
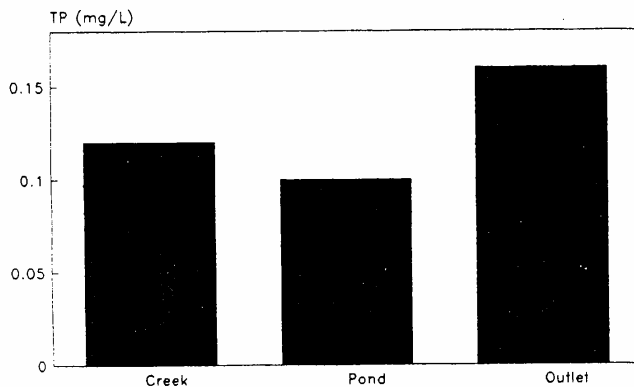
Figure 13. Comparison of Total Phosphorus Among the Three Stations for Individual Sampling Dates of 1989.

While the wetland slightly reduces phosphorus concentrations in the creek, the pond, as evidenced by our data from May and June, functions as a net exporter of phosphorus downstream. Outlet total phosphorus concentrations during these two months were 17-60% greater

than found at the upstream pond station suggesting that the sediments of the pond are enriched in phosphorus delivered from the watershed via the creek and that such phosphorus is easily recycled.

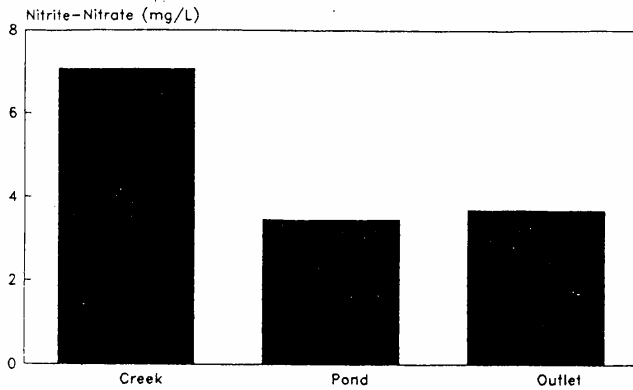
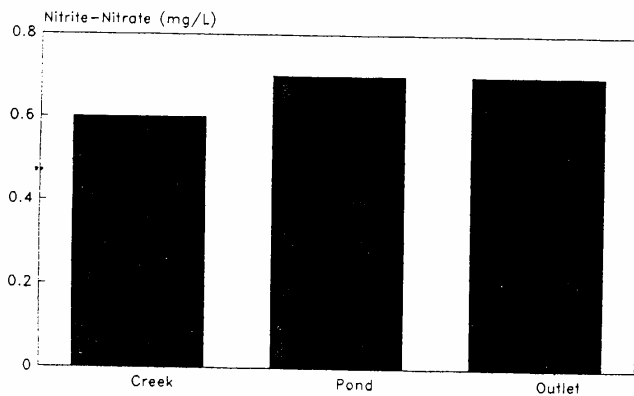
Figure 14. Comparison of Nitrate-Nitrite Nitrogen Among the Three Stations for Individual Sampling Dates of 1989.

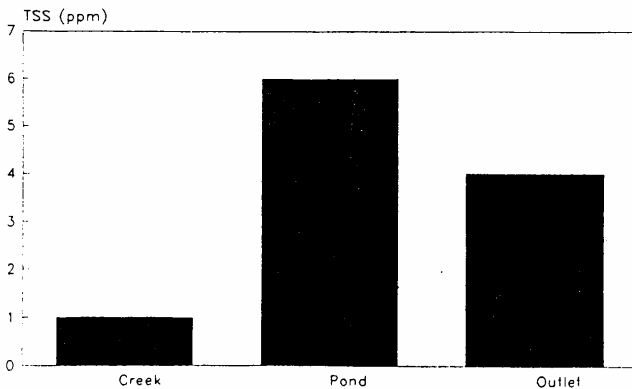
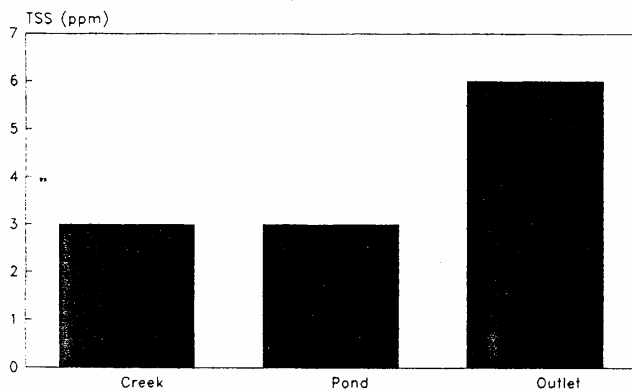
Figure 15. Comparison of Total Dissolved Solids Among the Three Stations for Individual Sampling Dates of 1989.

Total suspended solids (TSS) is a measure of organic and inorganic matter suspended in water. This parameter failed to display a clear trend (Figure 15). The wetland reduced TSS loading to the pond during March, increased it during May, and had no effect during June. Similarly, outlet TSS values were higher than the pond during March and June and lower during May. The increased export of TSS from the pond is attributed to algal blooms rather than release of inorganic sediment.

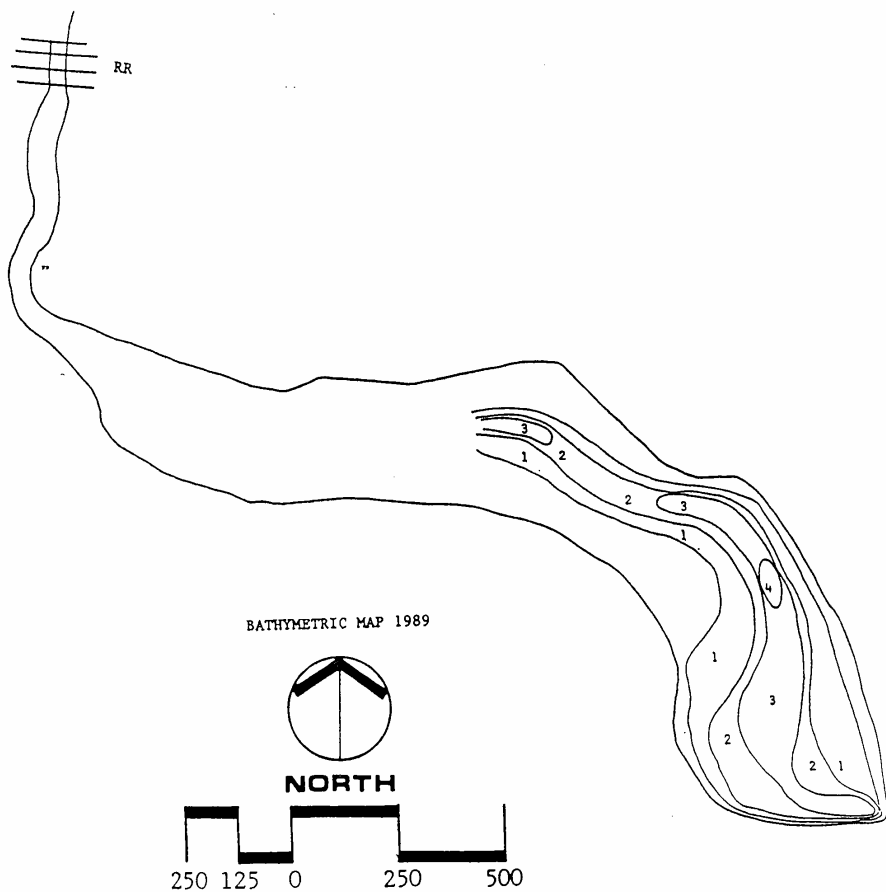
Figure 16. 1989 Bathymetric Map for Mill Pond.

A Raytheon recording fathometer was used to construct a bathymetric map for Mill Pond (Figure 16). Our mapping effort extended upstream to the point where the creek formed

a distinct channel through the wetland. It is clear that the creek has maintained a distinct channel through Mill Pond to the outlet structure. This channel is 3-4 feet deep and is clearly identifiable during summer as the last section of the lake to become completely weed choked.

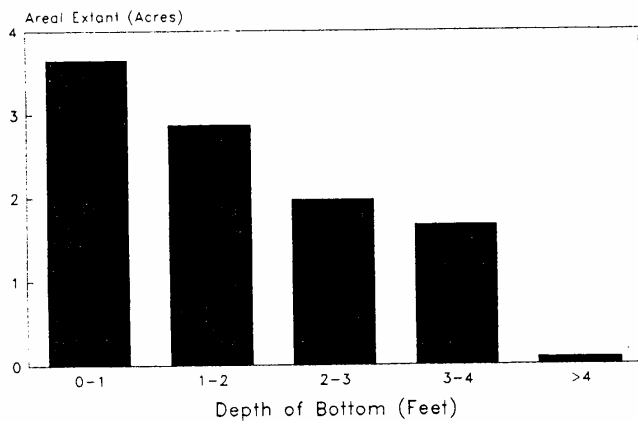
Figure 17. Aerial Extent of Individual One-Foot Depth Contours of Mill Pond for 1989.

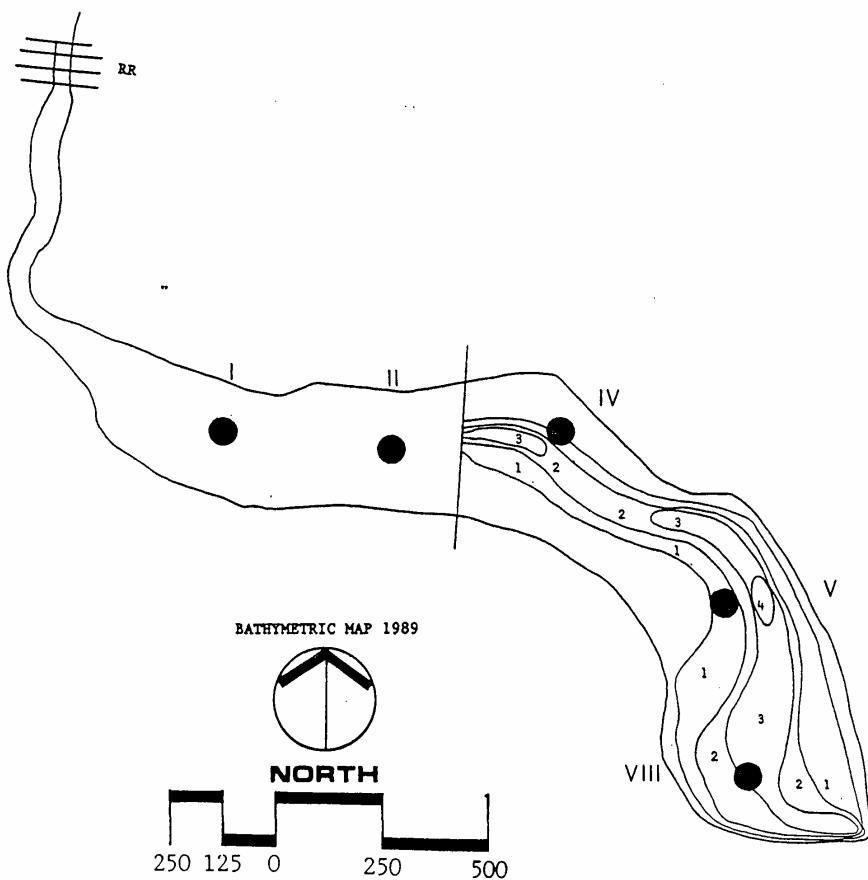
Figure 18. Locations of Sediment Cores Used for Drawdown Experiments.

Our investigation was designed to simulate drawdown on undisturbed sediments from Mill Pond and to determine whether such action would reduce phosphorus release from the pond bottom. Sediment cores approximately one meter long were collected at five locations in Mill Pond by means of a piston coring device equipped with a clear plexiglass tube (Figure 18). Special care was taken to insure that the

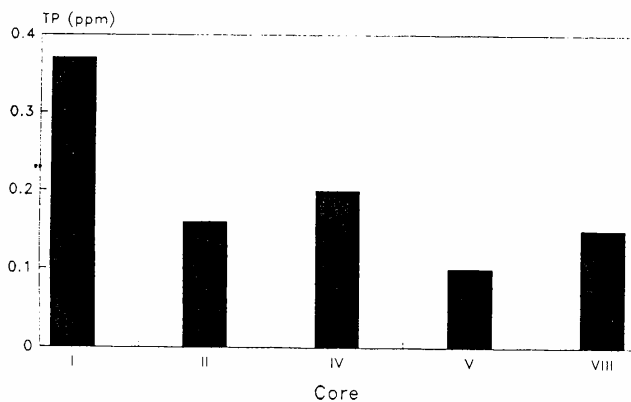
Figure 19. Total Phosphorus Release from Drawdown Cores Following Desiccation and Reflooding.

sediment-water interface was preserved intact for each core. The cores were transported upright to the laboratory, where the overlying water was drawn off and the sediment surface allowed to dry out thoroughly. After complete desiccation, distilled water was added to the core tubes to simulate reflooding. The same volume of water was added to all cores. After two weeks, samples of overlying water from each core were collected and analyzed for total phosphorus concentration. A sample of the same distilled water used for the experiment was also analyzed for total phosphorus to serve as a control situation. The results of core phosphorus release following subtraction of the control are provided in Figure 19.

Total phosphorus release from reflooded cores ranged from .10 mg/L to .37 mg/L. The lowest release was from the core taken at the center of the pond basin and the highest was from the core taken farthest upstream in the wetland. We observed in the field that the sediments being deposited in the upper wetland were extremely "soupy" suggesting ease of phosphorus recycling. Sediments within the pond proper were more compact and thus more likely to retain phosphorus.

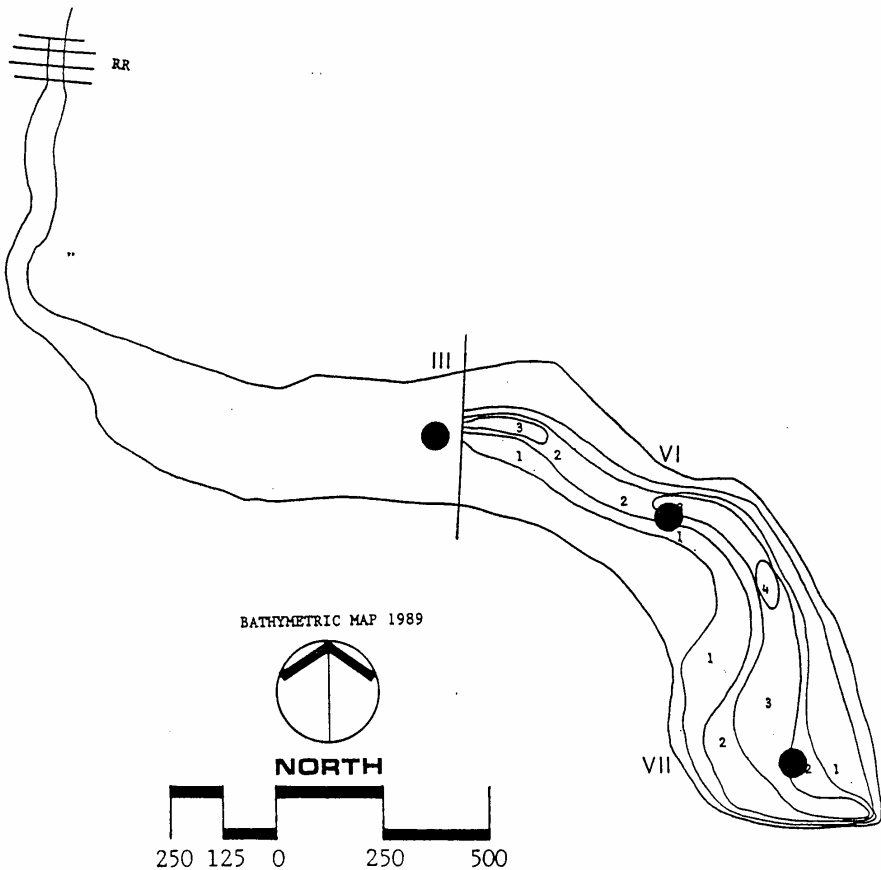
Figure 20. Locations of Sediment Cores Used for Physical and Chemical Profiles as Part of Dredging Study.

insure that the sediment-water interface was preserved intact for each core. The cores were transported upright to the laboratory where they were extruded within two hours of collection and sectioned at 1 cm intervals with each sample being placed in a plastic bag for storage. All samples were then kept at 4° C until analyzed.

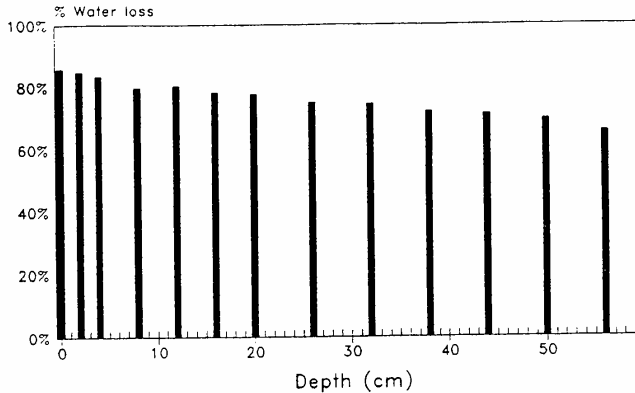
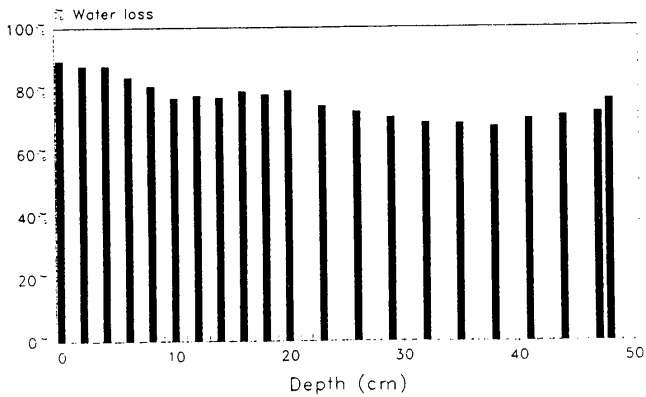
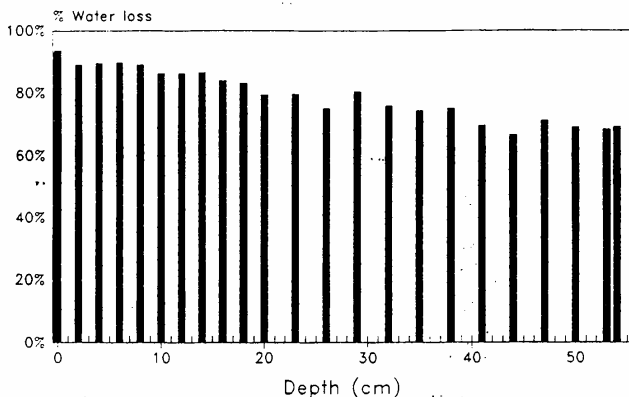
Figure 21. Profiles of Percent Water in Sediment Cores from Mill Pond.

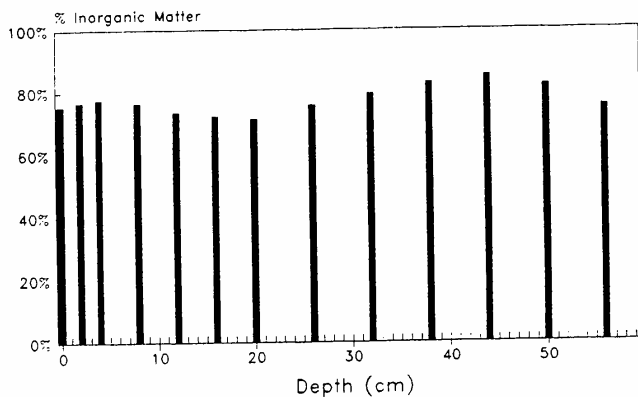
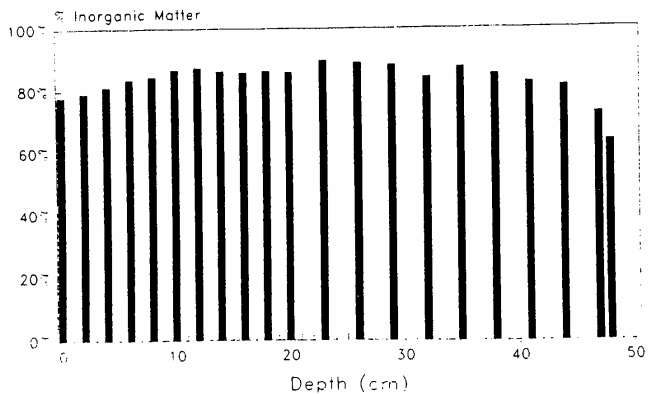
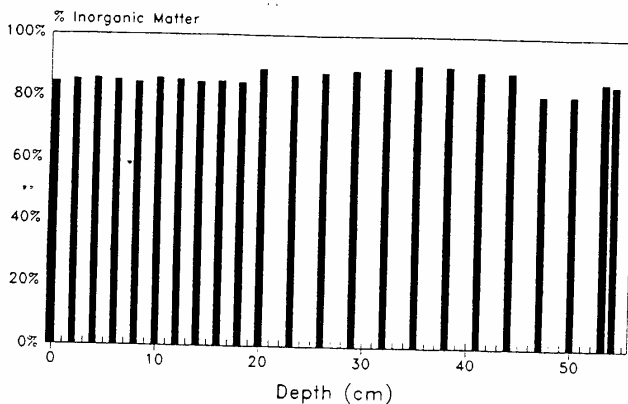
Figure 22. Profiles of Percent Inorganic Matter in Sediment Cores from Mill Pond.

It is indeed unusual to find such highly inorganic sediments in eutrophic lakes. Normally, one would expect >80% inorganic matter in either extremely unproductive lakes (oligotrophic) or reservoirs receiving heavy sediment loads from upstream. Such a finding at Mill Pond is a clear indication of the extent of watershed erosion and deposition of inorganic material in the pond and supports our earlier

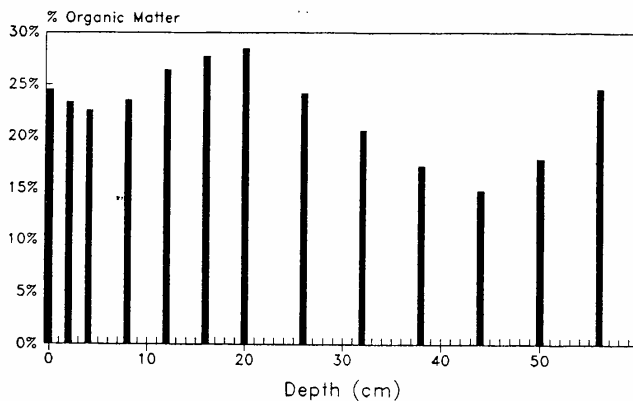
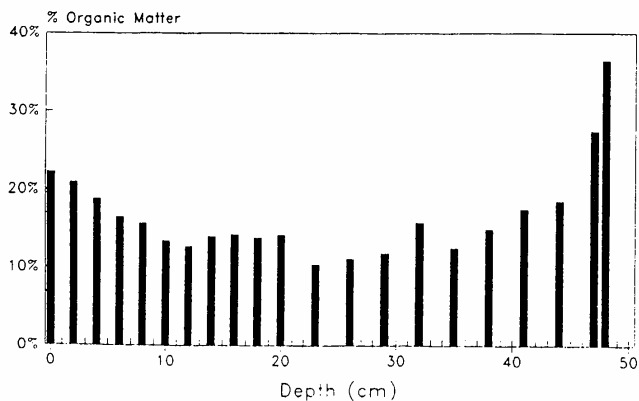
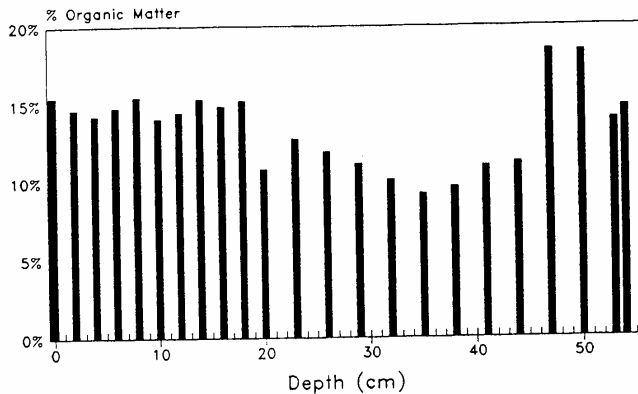
Figure 23. Profiles of Percent Organic Matter in Sediment Cores from Mill Pond.

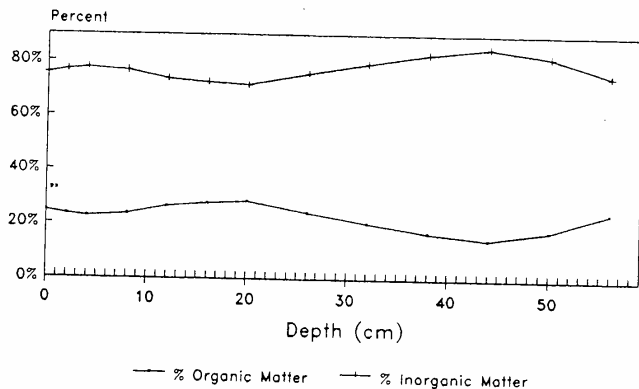
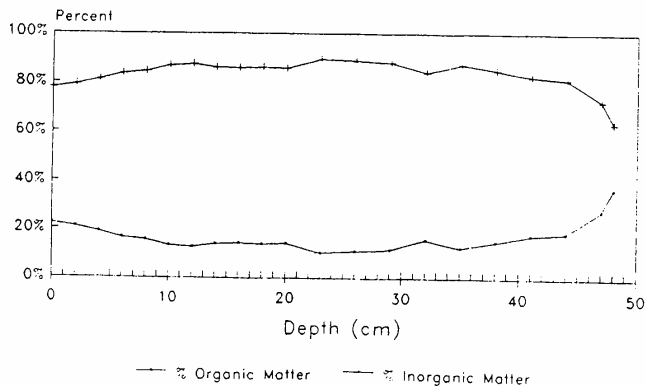
Figure 24. Comparison of Profiles of Inorganic and Organic Matter in Sediment Cores from Mill Pond.

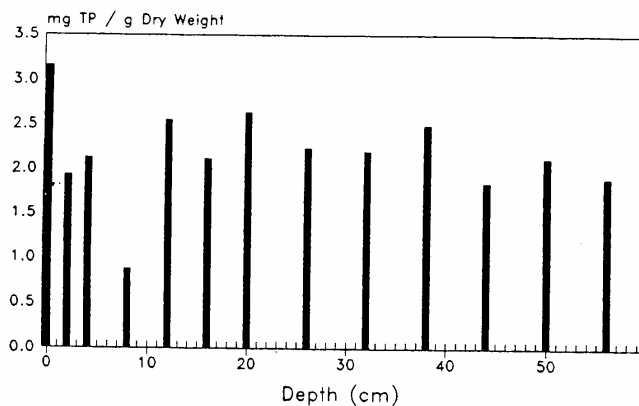
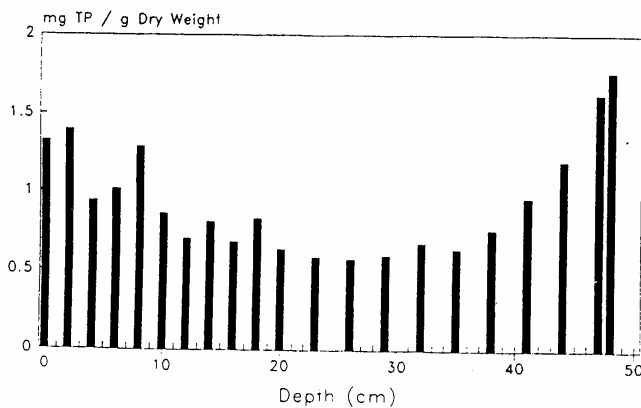
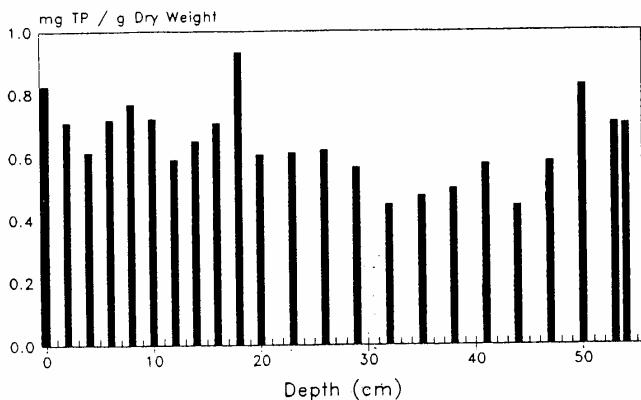
Figure 25. Profiles of Total Phosphorus Concentrations in Sediment Cores from Mill Pond.

In situations such as Mill Pond where the percentage of inorganic and organic matter does not change appreciably along the length of a sediment core, it is conventional to express total phosphorus concentrations as a function of the total dry weight of sediment at a particular depth in the core. In this way, deviations in the total phosphorus to sediment dry weight ratio can be used to delineate periods of past phosphorus enrichment in the lake (Figure 25). Sediment total phosphorus concentrations decreased downstream in the Mill Pond system with the highest values found in the wetland and the lowest in the pond proper near the dam. Phosphorus values in wetland sediments were approximately three times greater than near the dam. Such a trend indicates that the wetland and upper pond act as a trap for phosphorus entering the pond. Unfortunately, phosphorus loading to the Mill Pond system from the creek exceeds the retentive capacity of the wetland thus allowing sufficient phosphorus to enter the pond proper to accelerate the eutrophication process.

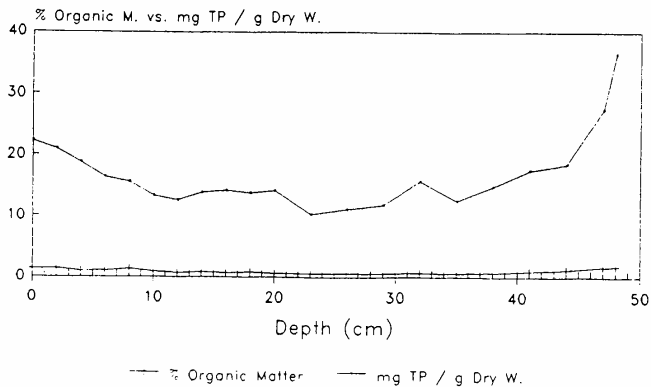
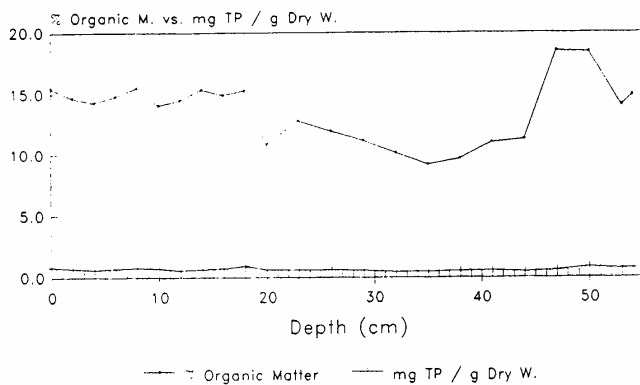
Figure 26. Comparison of Profiles of Organic Matter Percent and Total Phosphorus/Gram Sediment Dry Weight for Sediment Cores from Mill Pond.

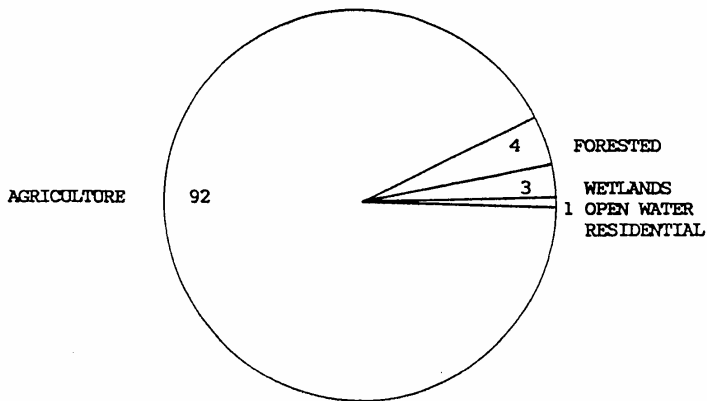
UNION MILLS WATERSHED

LAND USE DISTRIBUTION BY PERCENT

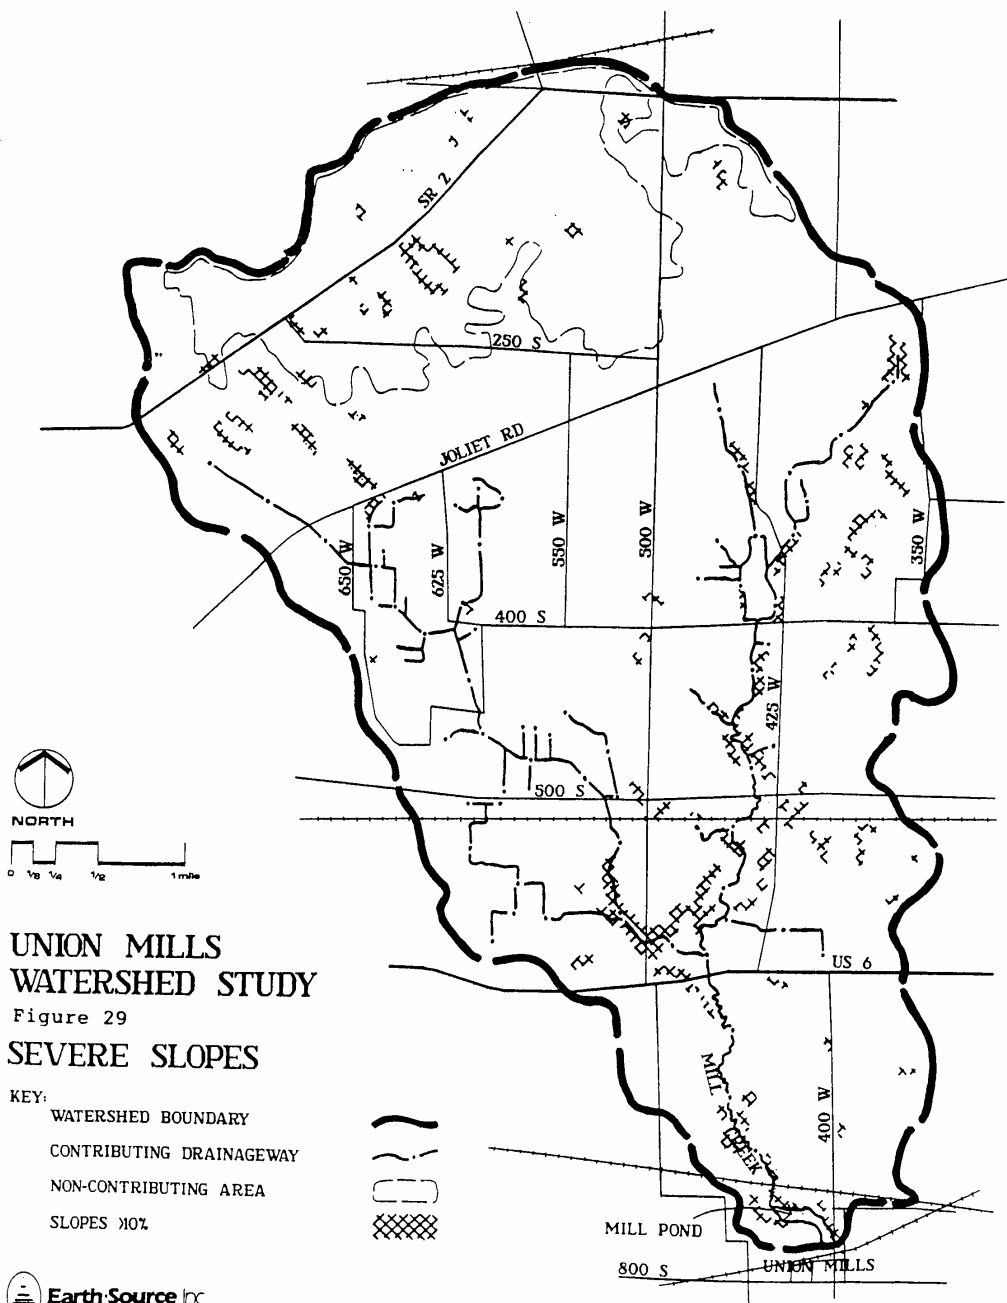
The intent of this study-map (Figure 29) is to further illustrate the fabric of the land forms in the watershed. This study provides further evidence where the study emphasis should be. Some of the slopes indicated are in an area identified as having a "low contribution" of sediments. This graphic also substantially matches the worst conditions of Highly Erodible Lands.

In general, any area mapped as having severe slopes should not be in agricultural crop production or should be in a conservation tillage program. Some of these sloped areas are also too steep for development without special care, if at all.

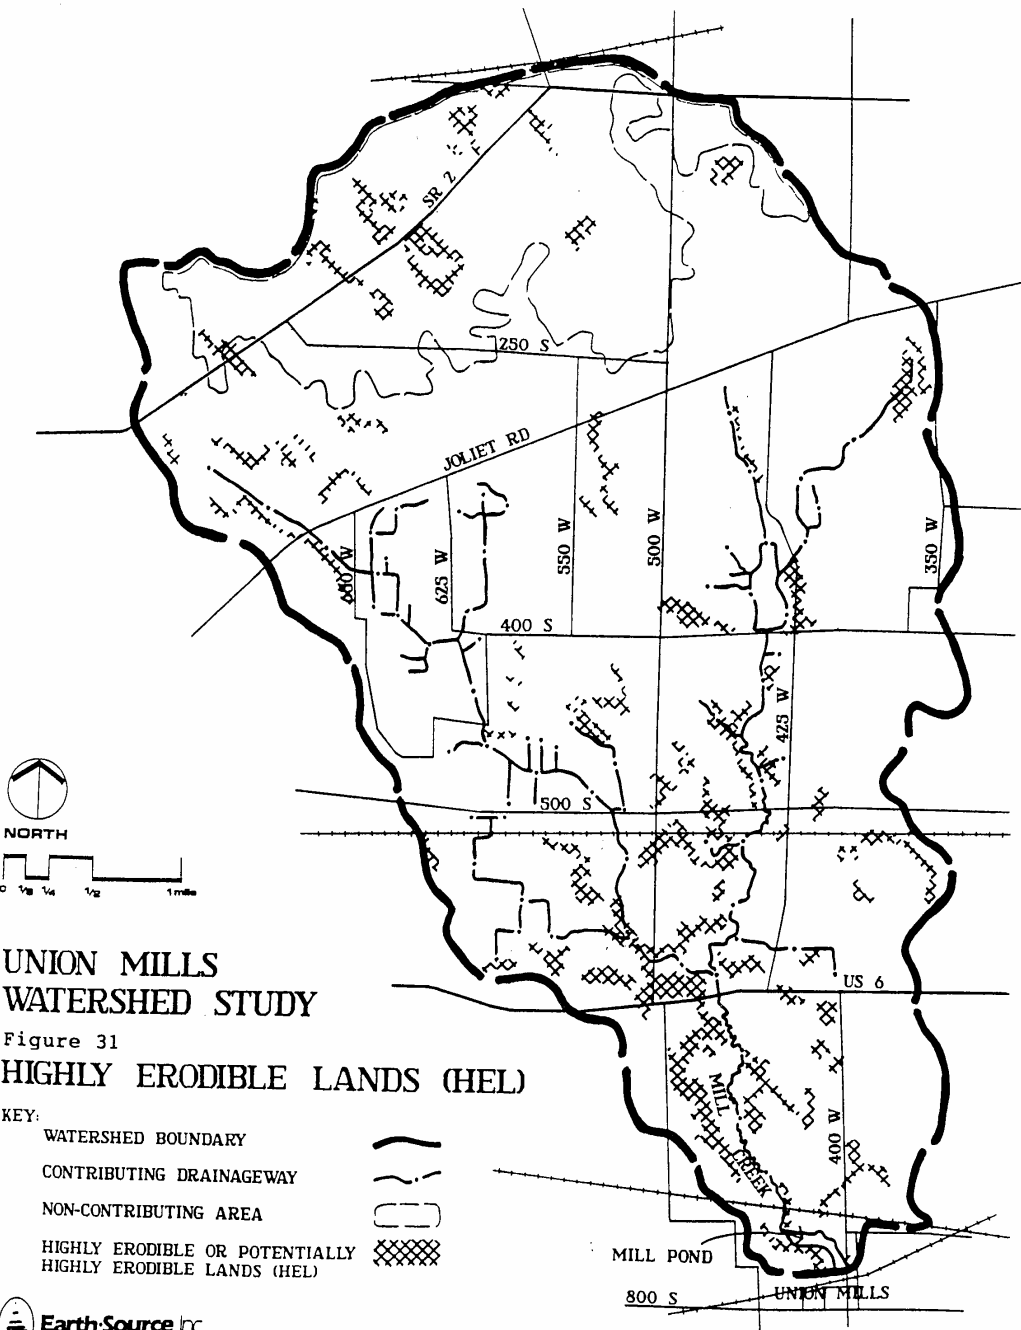
The intent of this overlay (Figure 32) is to further emphasize the areas of the watershed where severe erosion problems are likely to occur. The majority of the areas defined in the HEL/severe slope overlay are adjacent to open ditches which facilitate the transport of eroded soils to the Mill Pond. For this reason, those areas present the greatest sedimentation threat to the Mill Pond. Every effort should be made to enlist those lands into CRP or related land treatment programs. It is apparent from the HEL/severe slope overlay and various watershed tours during the course of this study, that the majority of the critical erosion areas of the watershed have not been fully addressed. The central reaches of the watershed contain lands where critical erosion problems are likely to occur. These lands should not be in agricultural crop production without utilizing soil conservation tillage practices.

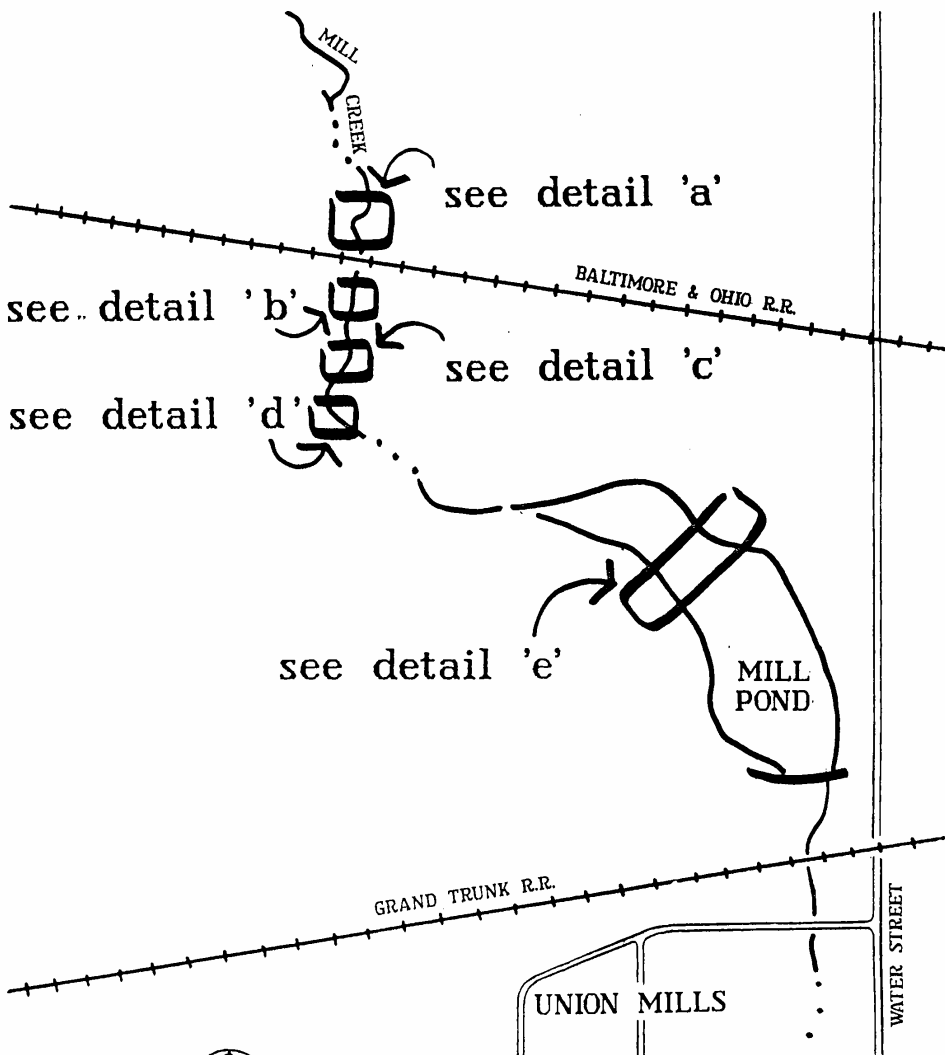
Figure 34
**UNION MILLS
 WETLAND CONCEPTS
 LOCATION MAP**

3. Detail 'b', 'c', and 'd'. This project is intended to divert flow from the channel to the wetland at the upper end. The project would provide semi-long term utilization of the wetland, however the wetland would rechannelize in time.
